**Flood Control Project Maintenance
Levee Inspections**

Fall 2015 Levee Maintenance Deficiency Summary Report

Sacramento River Basin

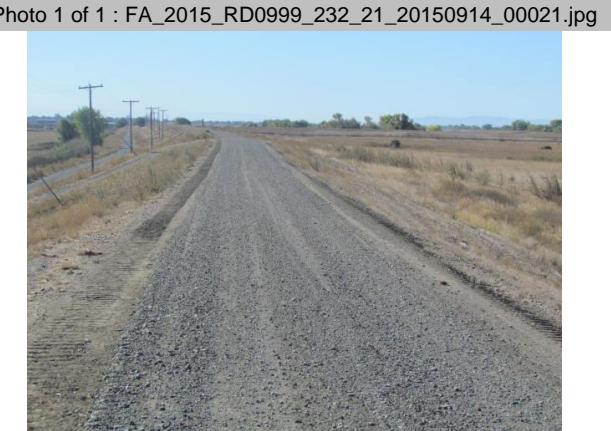
LM Start	12.53	Rating **	M	Issue No.	21									
LM End	12.60	Issue Type +	Ma	Location *	CR									
Category	Earthen Levee			GPS Latitude/Longitude										
				Start	End									
Item	Crown Surface / Depressions / Rutting			38.332288 °	38.331247 °									
				-121.644640 °	-121.644765 °									
DWR ID	DWR_RD0999_01_s_2012_21													
Action/Comments														
Add appropriate gravel or road base. Grade and compact. Inspector Comments: Ruts have been fixed, but need to add appropriate gravel or road base.

Looking south at graded levee crown.(Fall 2014)

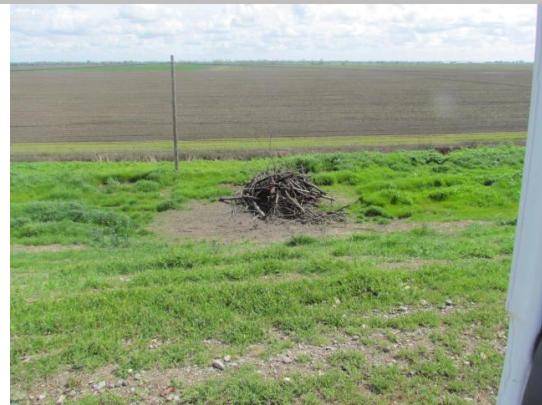
Photo 1 of 1 : FA_2015_RD0999_232_59_20150914_00069.jpg

LM Start	13.46	Rating **	M	Issue No.	59										
LM End	13.46	Issue Type +	Ma	Location *	LS										
Category	Earthen Levee			GPS Latitude/Longitude											
				Start	End										
Item	Encroachments			38.318717 °	38.318717 °										
				-121.644955 °	-121.644955 °										
DWR ID	DWR_RD0999_01_s_2015_59														
Action/Comments															
Prunings Inspector Comments: Pruning pile on landward berm.

Looking east at pruning pile on landward berm.

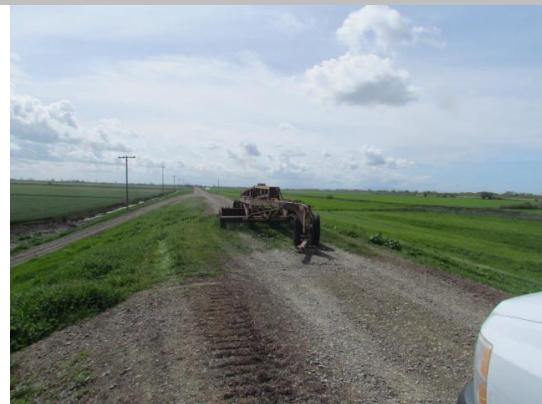
Photo 1 of 1 : FA_2015_RD0999_232_63_20150914_00071.jpg

LM Start	13.79	Rating **	A/W	Issue No.	63										
LM End	13.79	Issue Type +	En	Location *	CR										
Category	Earthen Levee			GPS Latitude/Longitude											
				Start	End										
Item	Encroachments			38.314006 °	38.314006 °										
				-121.644961 °	-121.644961 °										
DWR ID	DWR_RD0999_01_s_2015_63														
Action/Comments															
Equipment Inspector Comments: Landowner or farmer stored a land plane leveler in the middle of levee crown. The equipment is blocking access.

Looking south at farm equipment (land plane leveler) left on levee crown. (Spring 2015)

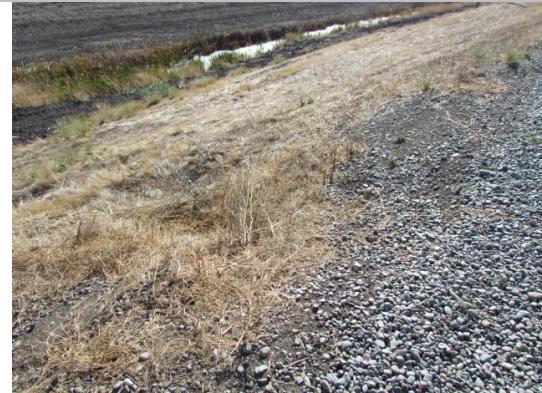
Photo 1 of 4 : FA_2015_RD0999_232_49_20151106_00095.jpg

LM Start	14.04	Rating **	U	Issue No.	49							
LM End	14.04	Issue Type +	Ma	Location *	LS							
Category	Earthen Levee		GPS Latitude/Longitude									
			Start	End								
Item	Erosion / Bank Caving		38.310347 °	38.310347 °	-121.644955 °	-121.644955 °						
DWR ID	DWR_RD0999_01_f_2012_49											
Action/Comments												
Note and monitor erosion site. Inspector Comments: Caving, 4' x 10', on landside slope.

Looking southeast at caving on landward slope fall 2015.

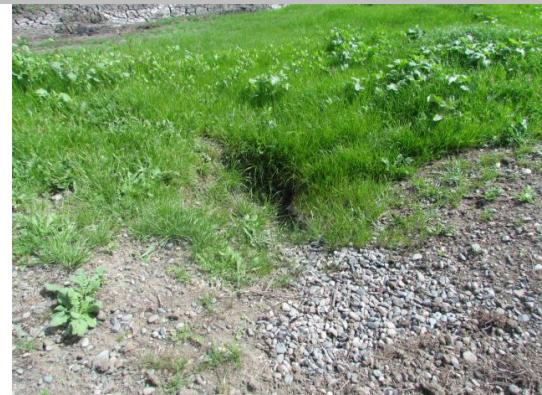
Photo 2 of 4 : FA_2015_RD0999_232_49_20150914_00061.jpg

Looking east at caving on landward shoulder and slope. (Spring 2015)

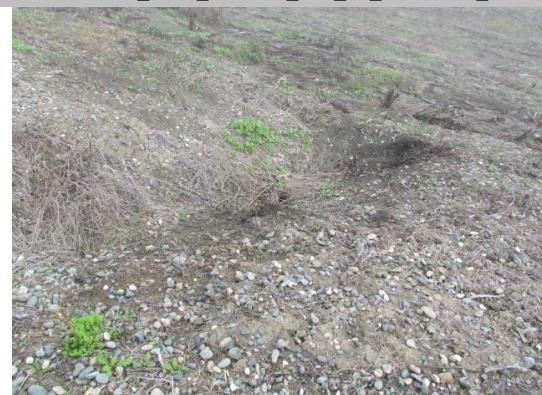
Photo 3 of 4 : FA_2015_RD0999_232_49_20150914_00062.jpg

Looking southeast at caving on landside slope.

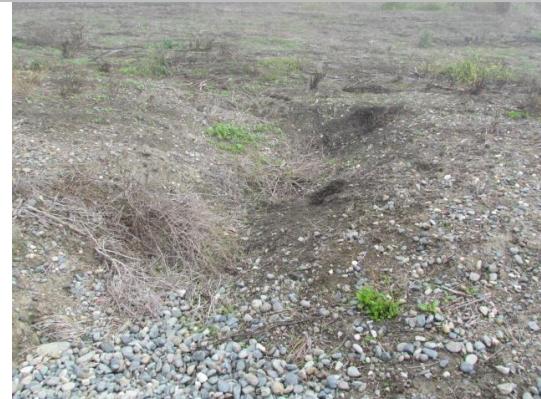
Photo 4 of 4 : FA_2015_RD0999_232_49_20150914_00063.jpg

LM Start	14.04	Rating **	U	Issue No.	49 (cont)									
LM End	14.04	Issue Type +	Ma	Location *	LS									
Category	Earthen Levee			GPS Latitude/Longitude										
				Start	End									
Item	Erosion / Bank Caving			38.310347 °	38.310347 °									
				-121.644955 °	-121.644955 °									
DWR ID	DWR_RD0999_01_f_2012_49													
Action/Comments														
Note and monitor erosion site. Inspector Comments: Caving, 4' x 10', on landside slope.

Looking east caving on landside slope.

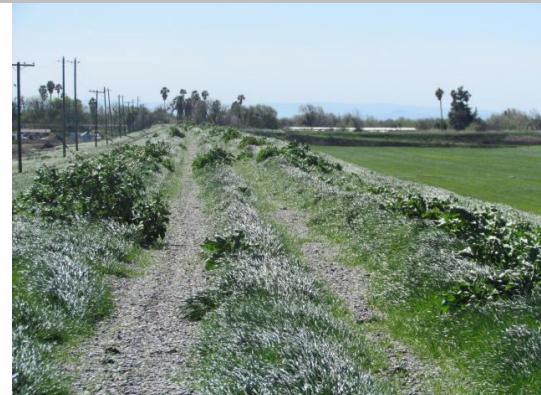
Photo 1 of 1 : FA_2015_RD0999_232_44_20150914_00054.jpg

LM Start	14.33	Rating **	A/W	Issue No.	44									
LM End	15.17	Issue Type +	Ma	Location *	CR									
Category	Earthen Levee			GPS Latitude/Longitude										
				Start	End									
Item	Crown Surface / Depressions / Rutting			38.306113 °	38.293917 °									
				-121.644942 °	-121.644958 °									
DWR ID	DWR_RD0999_01_s_2012_44													
Action/Comments														
Add appropriate material and re-grade the levee to bring the crown above the design elevation. Inspector Comments: Control growth on levee crown.

Looking south at growth on levee crown.

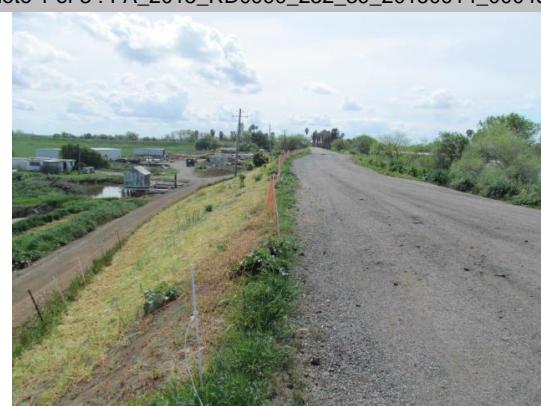
Photo 1 of 3 : FA_2015_RD0999_232_39_20150914_00046.jpg

LM Start	15.27	Rating **	M	Issue No.	39									
LM End	15.41	Issue Type +	En	Location *	LS									
Category	Earthen Levee			GPS Latitude/Longitude										
				Start	End									
Item	Encroachments			38.292578 °	38.290525 °									
				-121.644972 °	-121.644902 °									
DWR ID	DWR_RD0999_01_s_2012_39													
Action/Comments														
Fence Inspector Comments: Landowner has installed fence along landside slope for sheep to maintain levee slope. Landowner should apply for permit for fence. Landowner added additional fencing on landward shoulder and slope.

Looking east at new fencing on landward shoulder and slope. (Spring 2015)

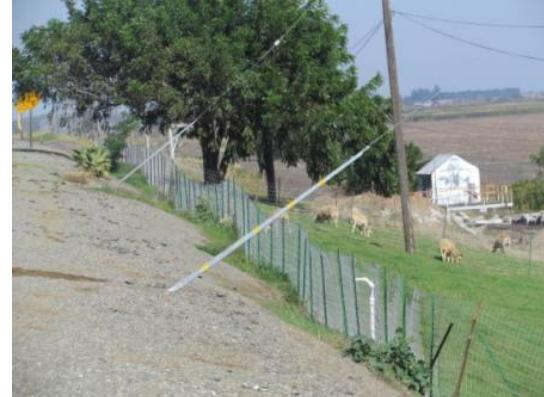
Photo 2 of 3 : FA_2015_RD0999_232_39_20150914_00047.jpg

Looking north at fence along landside slope.

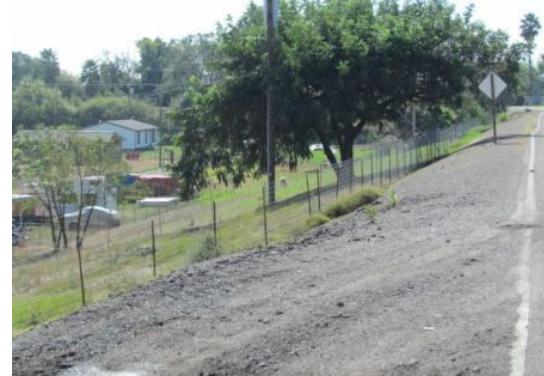
Photo 3 of 3 : FA_2015_RD0999_232_39_20150914_00048.jpg

Looking south at fence along landside slope.

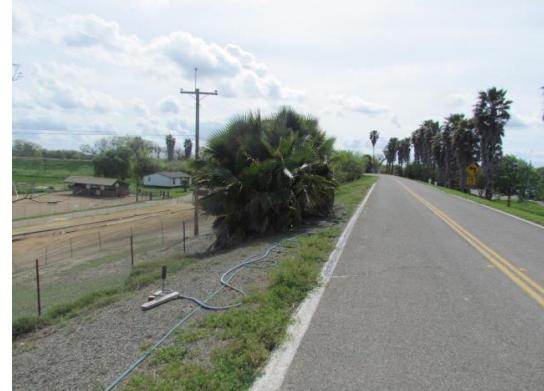
Photo 1 of 3 : FA_2015_RD0999_232_50_20150914_00064.jpg

LM Start	15.33	Rating **	M	Issue No.	50																		
LM End	15.33	Issue Type +	Ma	Location *	LS																		
Category	Earthen Levee			GPS Latitude/Longitude																			
				Start	End																		
Item	Encroachments			38.291663 °	38.291663 °																		
				-121.644962 °	-121.644962 °																		
DWR ID	DWR_RD0999_01_f_2012_50																						
Action/Comments																							
Tree or limb Inspector Comments: Newly planted palm trees on landside shoulder.

Looking northeast at a mature palm trees on landward shoulder and slope. (Spring 2015)

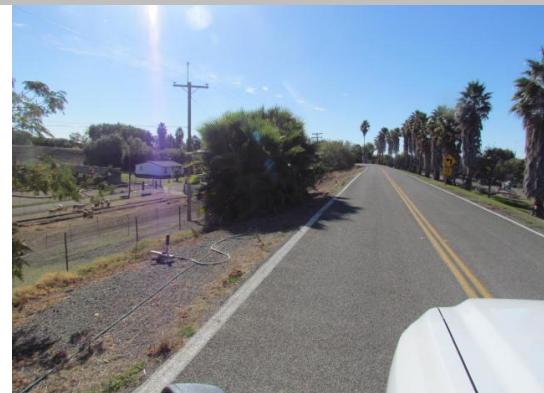
Photo 2 of 3 : FA_2015_RD0999_232_50_20150914_00065.jpg

Looking east at a maturing palm trees on landward shoulder and slope. (Fall 2014)

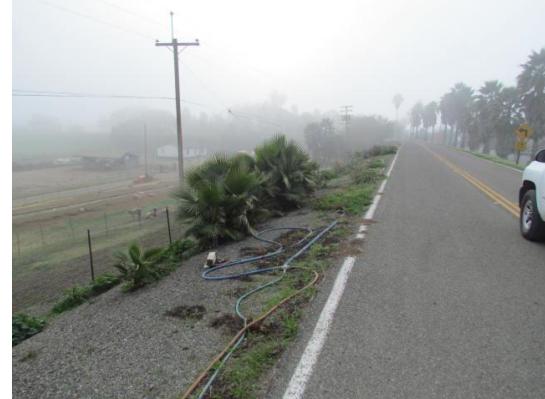
Photo 3 of 3 : FA_2015_RD0999_232_50_20150914_00066.jpg

LM Start	15.33	Rating **	M	Issue No.	50 (cont)															
LM End	15.33	Issue Type +	Ma	Location *	LS															
Category	Earthen Levee			GPS Latitude/Longitude																
				Start	End															
Item	Encroachments			38.291663 °	38.291663 °															
				-121.644962 °	-121.644962 °															
DWR ID	DWR_RD0999_01_f_2012_50																			
Action/Comments																				
Tree or limb Inspector Comments: Newly planted palm trees on landside shoulder.

Looking east at newly planted palm trees on landside shoulder and slope.

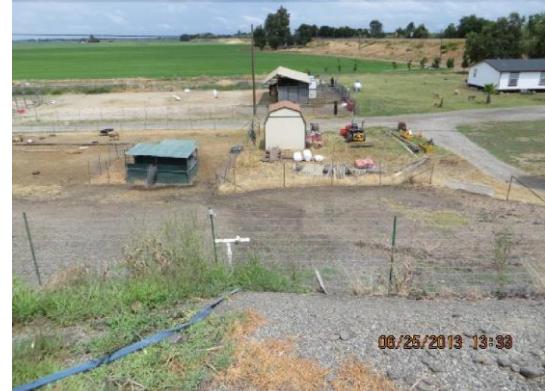
Photo 1 of 3 : UCIP_FA_2015_1482.jpg

LM Start	15.36	Rating **	M	Issue No.	927												
LM End	15.36	Issue Type +	En	Location *	LS												
Category	Supplemental			GPS Latitude/Longitude													
				Start	End												
Item	DWR UCIP Field Study			38.291192 °	38.291192 °												
				-121.644987 °	-121.644987 °												
DWR ID																	
Action/Comments																	
Inspector Comments: FS_ID:16330 DS_ID:23970 EP_NO: N/A FS_HLM: 15.374 Repair Type: Non-Urgent Crossing Status: Found UCIP Comments: No permit identified for this crossing. FIELD_STRUCT_DESC: 4-inch PVC waterline through the levee 2-feet below the crown. Pump off WS toe visible at waters edge. FS Date: 06/25/2013

Pipe visible on LS toe.

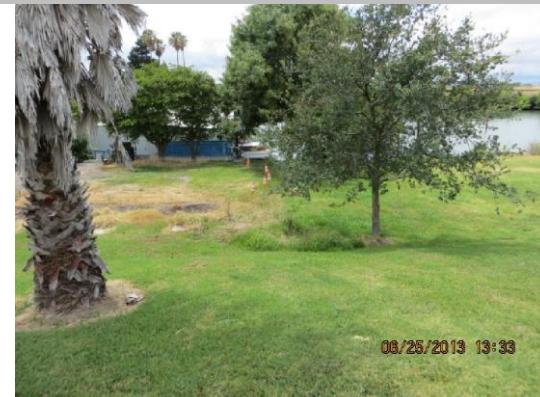
Pipe visible at WS toe in grass.

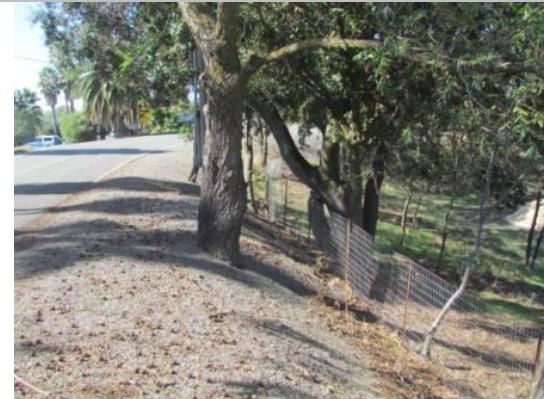
Photo 1 of 2 : FA_2015_RD0999_233_17_20150914_00018.jpg

LM Start	0.01	Rating **	M	Issue No.	17										
LM End	0.06	Issue Type +	En	Location *	LS										
Category	Earthen Levee		GPS Latitude/Longitude												
			Start	End											
Item	Encroachments		38.290355 °	38.290472 °											
			-121.644713 °	-121.643888 °											
DWR ID	DWR_RD0999_02_s_2012_17														
Action/Comments															
Fence Inspector Comments: Landowner has installed fence along landside slope for sheep to maintain levee slope. Landowner should apply for permit to keep fence.

Looking west at fence along landside slope.

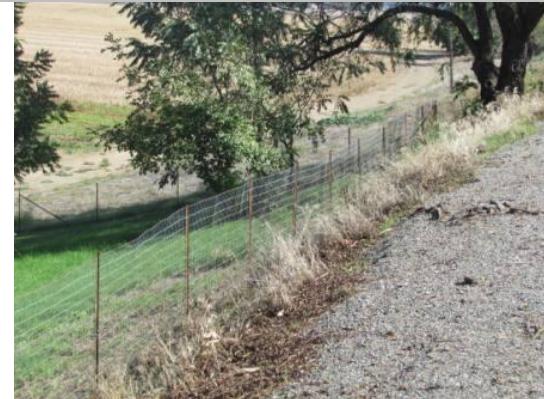
Photo 2 of 2 : FA_2015_RD0999_233_17_20150914_00019.jpg

Looking northeast at fence along landside shoulder.

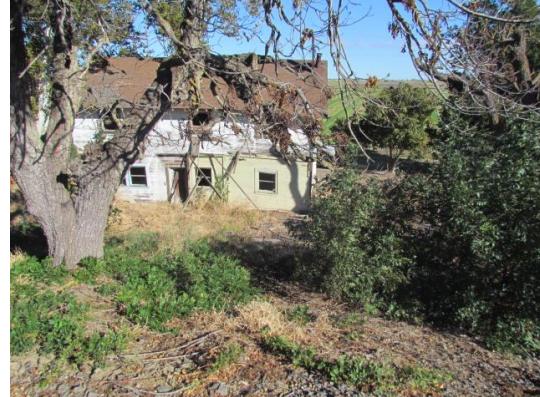
Photo 1 of 2 : FA_2015_RD0999_233_24_20150914_00029.jpg

LM Start	0.18	Rating **	U	Issue No.	24				
LM End	0.18	Issue Type +	En	Location *	LS				
Category	Earthen Levee			GPS Latitude/Longitude					
				Start	End				
Item	Encroachments			38.290871 °	38.290871 °				
				-121.641755 °	-121.641755 °				
DWR ID	DWR_RD0999_02_f_2013_24						Action/Comments		
Building	Inspector Comments: Adandoned building on landward toe and berm.

Looking southwest at abandoned building on landward berm.

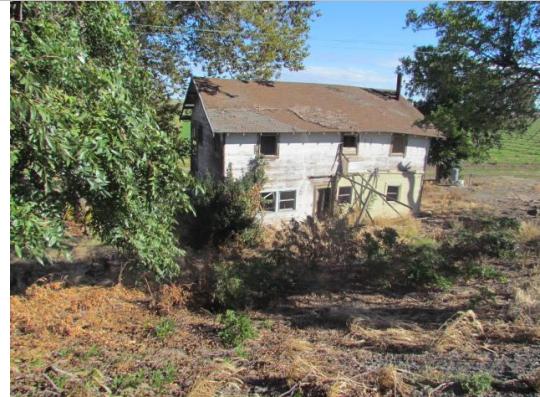
Photo 2 of 2 : FA_2015_RD0999_233_24_20150914_00030.jpg

Looking west at abandoned building on landward berm.

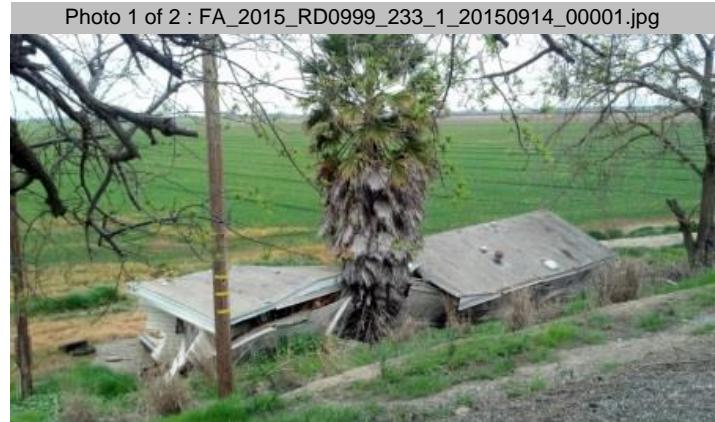
LM Start	0.21	Rating **	U	Issue No.	1		Photo 1 of 2 : FA_2015_RD0999_233_1_20150914_00001.jpg								
LM End	0.21	Issue Type +	En	Location *	LS										
Category	Earthen Levee			GPS Latitude/Longitude											
				Start	End										
Item	Encroachments			38.290859 °	38.290859 °										
				-121.641220 °	-121.641220 °										
DWR ID	DWR_RD0999_02_f_2012_1														
Action/Comments															
Building Inspector Comments: Dilapidated building at landside toe.

Looking northwest at dilapidated building on landside toe. Spring 2013

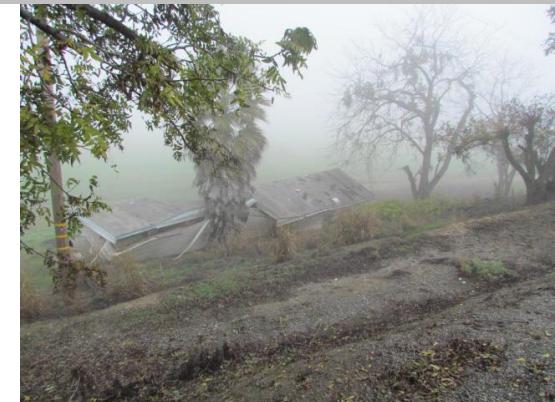
Photo 2 of 2 : FA_2015_RD0999_233_1_20150914_00002.jpg

LM Start	0.21	Rating **	U	Issue No.	1 (cont)	
LM End	0.21	Issue Type +	En	Location *	LS

Looking northwest at dilapidated building at landside toe.

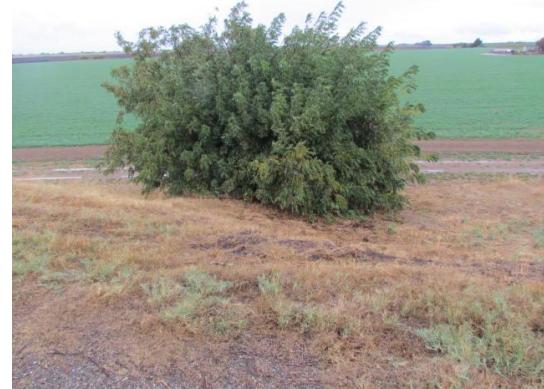
Photo 1 of 1 : FA_2015_RD0999_233_37_20151106_00045.jpg

Looking east at untrimmed tree on landward slope.

LM Start	0.73	Rating **	U	Issue No.	37										
LM End	0.73	Issue Type +	Ma	Location *	LS										
Category	Earthen Levee			GPS Latitude/Longitude											
				Start	End										
Item	Trim / Thin Trees			38.292783 °	38.292783 °										
				-121.632317 °	-121.632317 °										
DWR ID	DWR_RD0999_02_s_2014_37														
Action/Comments															
Trim trees to at least five feet above ground level.

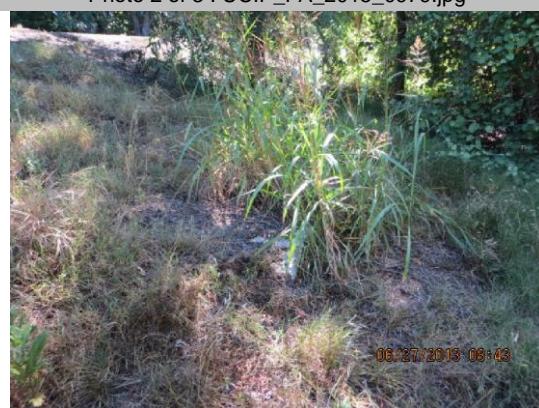
LM Start	0.79	Rating **	M	Issue No.	45 (cont)	Action/Comments			
LM End	0.79	Issue Type +	En	Location *	WS

Concrete pad on WS slope.

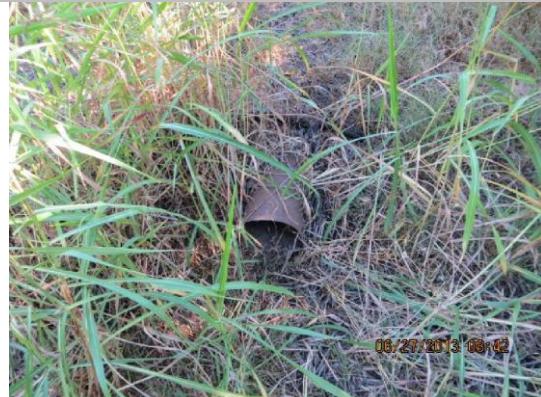
Photo 3 of 3 : UCIP_FA_2015_0980.jpg

LM Start	0.79	Rating **	M	Issue No.	45 (cont)									
LM End	0.79	Issue Type +	En	Location *	WS									
Category	Supplemental			GPS Latitude/Longitude										
				Start	End									
Item	DWR UCIP Field Study			38.292562 °	38.292562 °									
				-121.631331 °	-121.631331 °									
DWR ID														
Action/Comments														
Inspector Comments: FS_ID:15384 DS_ID:22772 EP_NO: N/A FS_HLM: 0.78 Repair Type: Non-Urgent Crossing Status: Found

06/27/2013 08:42
Pipe visible at concrete pad on WS slope.

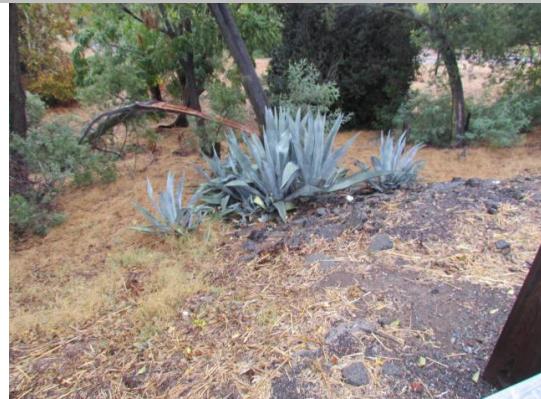
Photo 1 of 2 : FA_2015_RD0999_233_14_20151106_00043.jpg

LM Start	0.82	Rating **	U	Issue No.	14									
LM End	0.82	Issue Type +	Ma	Location *	LS									
Category	Earthen Levee			GPS Latitude/Longitude										
				Start	End									
Item	Vegetation			38.292439 °	38.292439 °									
				-121.630781 °	-121.630781 °									
DWR ID	DWR_RD0999_02_f_2012_14													
Action/Comments														
Remove the wild growth other than native grasses from the levee slopes.														
Inspector Comments: Century plant on landside slope.

Looking north at century plant at landward toe fall 2015.

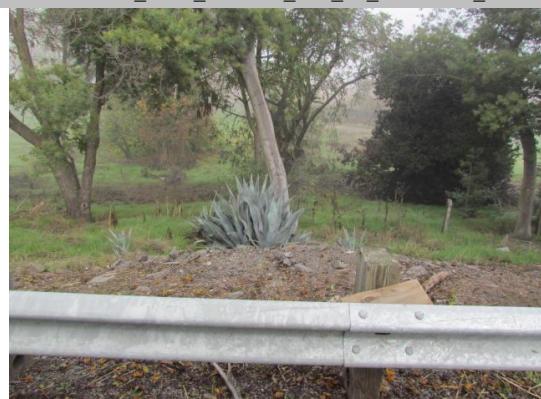
Photo 2 of 2 : FA_2015_RD0999_233_14_20150914_00015.jpg

Looking north at century plant at landside toe.

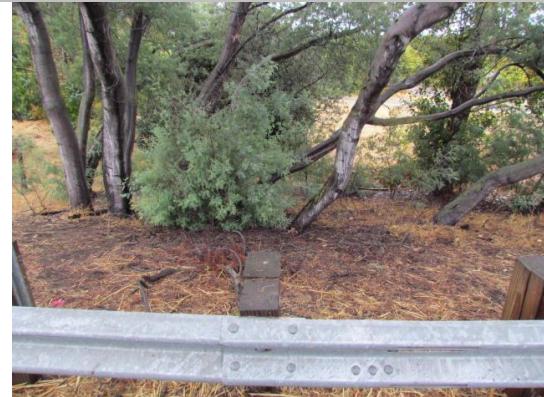
Photo 1 of 2 : FA_2015_RD0999_233_19_20151106_00046.jpg

Looking north at untrimmed and trees to be thinned at landward toe fall 2015.

LM Start	0.83	Rating **	U	Issue No.	19										
LM End	0.83	Issue Type +	Ma	Location *	LS										
Category	Earthen Levee			GPS Latitude/Longitude											
				Start	End										
Item	Trim / Thin Trees			38.292386 °	38.292386 °										
				-121.630543 °	-121.630543 °										
DWR ID	DWR_RD0999_02_f_2012_19														
Action/Comments															
Thin trees to allow visibility of the ground and room to flood fight.

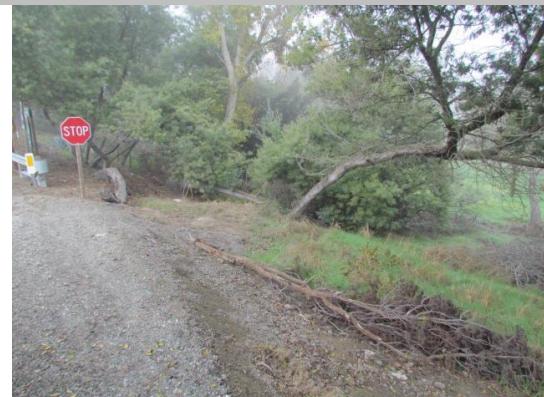
Photo 2 of 2 : FA_2015_RD0999_233_19_20150914_00022.jpg

Looking west at dense trees on landside slope and toe.

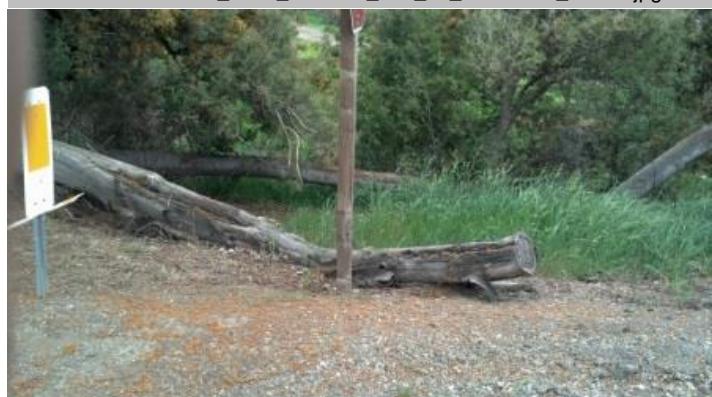
Photo 1 of 1 : FA_2015_RD0999_233_13_20150914_00014.jpg

LM Start	0.84	Rating **	M	Issue No.	13										
LM End	0.84	Issue Type +	En	Location *	LS										
Category	Earthen Levee			GPS Latitude/Longitude											
				Start	End										
Item	Encroachments			38.292352 °	38.292352 °										
				-121.630452 °	-121.630452 °										
DWR ID	DWR_RD0999_02_s_2012_13														
Action/Comments															
Tree or limb

Looking northwest at tree limb on landside slope.

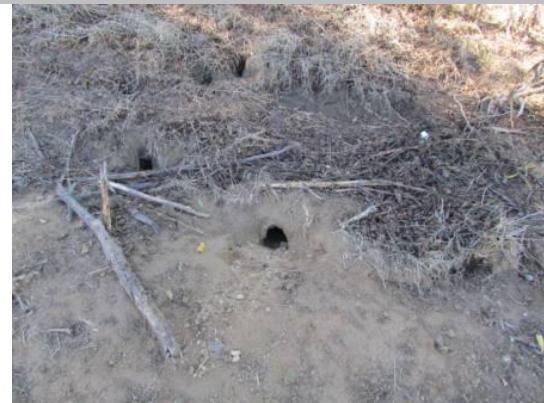
Photo 1 of 1 : FA_2015_RD0999_233_2_20150914_00003.jpg

Looking at several rodent holes on landside slope.

LM Start	0.93	Rating **	M	Issue No.	2												
LM End	1.03	Issue Type +	Ma	Location *	LS												
Category	Earthen Levee		GPS Latitude/Longitude														
			Start	End													
Item	Animal Control		38.291823 °	38.291250 °													
			-121.628973 °	-121.627285 °													
DWR ID	DWR_RD0999_02_s_2012_2																
Action/Comments																	
Exterminate rodents and backfill and compact or grout burrows.

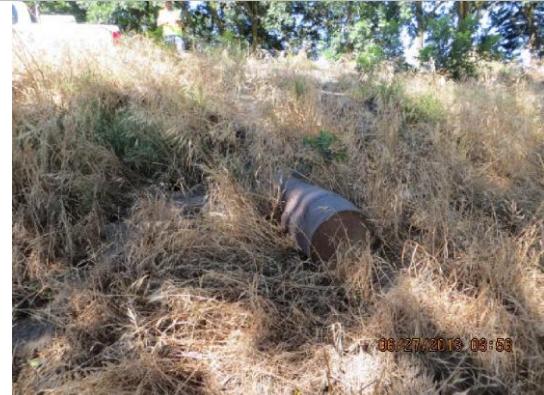
Photo 1 of 3 : UCIP_FA_2015_0981.jpg

LM Start	0.93	Rating **	M	Issue No.	46												
LM End	0.93	Issue Type +	En	Location *	LS												
Category	Supplemental		GPS Latitude/Longitude														
			Start	End													
Item	DWR UCIP Field Study		38.291739 °	38.291739 °													
			-121.628873 °	-121.628873 °													
DWR ID																	
Action/Comments																	
Inspector Comments: FS_ID:15385 DS_ID:22773 EP_NO: N/A FS_HLM: 0.93 Repair Type: Non-Urgent Crossing Status: Found UCIP Comments: Pipe should be abandoned properly. FIELD_STRUCT_DESC: *Abandoned* 10-inch steel irrigation pipe through levee 4.9 feet below crown. Capped on both ends. Originally included in the 1966 O&M manual. FS Date: 06/27/2013

Pipe with welded steel plate over end

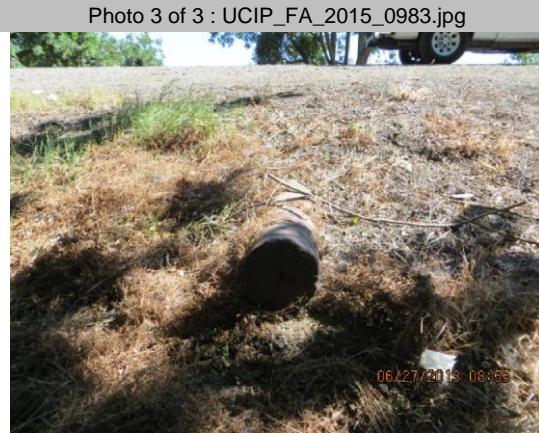
Pipe with welded steel plate over end visible on WS

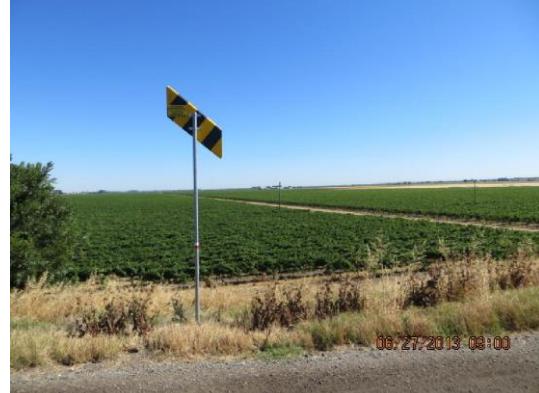
Gasline marker on LS shoulder.

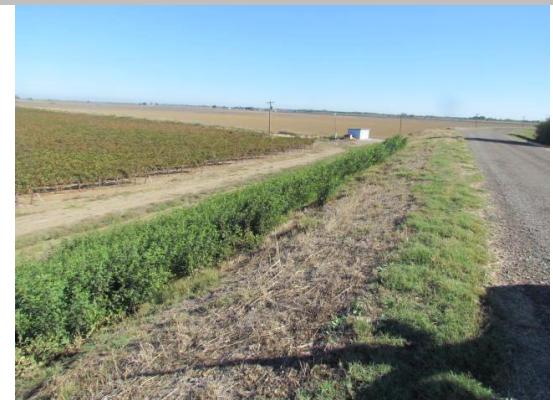
LM Start	1.19	Rating **	M	Issue No.	41		Photo 1 of 1 : FA_2015_RD0999_233_41_20150914_00034.jpg						
LM End	1.19	Issue Type +	Ma	Location *	LS								
Category	Earthen Levee			GPS Latitude/Longitude									
				Start	End								
Item	Vegetation			38.291185 °	38.291185 °								
DWR ID	DWR_RD0999_02_f_2014_41												
Action/Comments													
Remove the wild growth other than native grasses from the levee slopes. Inspector Comments: Dense wild roses on landward slope.

Looking north at moderate vegetation on landward slope and toe.

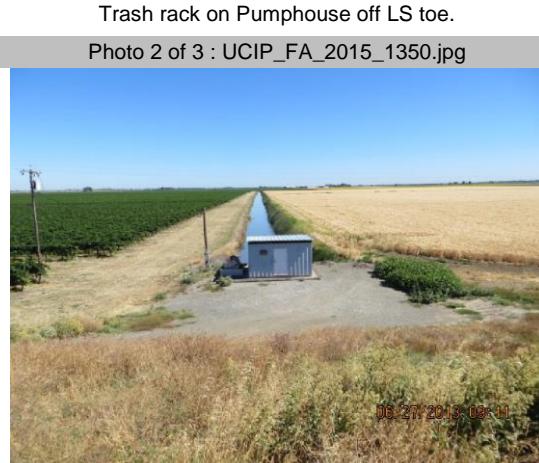
Pumphouse off LS toe.

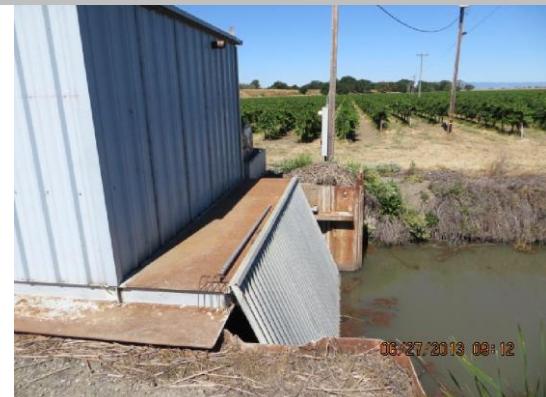
Photo 1 of 3 : UCIP_FA_2015_1352.jpg

LM Start	1.25	Rating **	M	Issue No.	49									
LM End	1.25	Issue Type +	En	Location *	LS									
Category	Supplemental			GPS Latitude/Longitude										
				Start	End									
Item	DWR UCIP Field Study			38.291381 °	38.291381 °									
				-121.623268 °	-121.623268 °									
DWR ID														
Action/Comments														
Inspector Comments: FS_ID:16334 DS_ID:23963 EP_NO: N/A FS_HLM: 1.241 Repair Type: Non-Urgent Crossing Status: Found UCIP Comments: Need to determine permit No. for this crossing. FIELD_STRUCT_DESC: 30-inch steel stormdrain through the levee 2.5-feet below the crown with a pump in a pumphouse on the LS toe. Siphon breaker in a 24-inch steel riser on WS. Permit No. 17064, 1999 FS Date: 06/27/2013

Pumphouse on LS toe with trash rack.

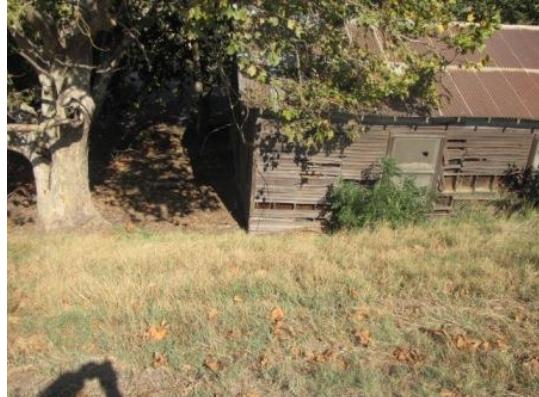
Photo 1 of 2 : FA_2015_RD0999_233_3_20150914_00004.jpg

LM Start	1.67	Rating **	U	Issue No.	3										
LM End	1.68	Issue Type +	En	Location *	LS										
Category	Earthen Levee		GPS Latitude/Longitude												
			Start	End											
Item	Encroachments		38.290287 °	38.290217 °											
			-121.615668 °	-121.615460 °											
DWR ID	DWR_RD0999_02_s_2012_3														
Action/Comments															
Building Inspector Comments: Old abandoned storage shed on landward toe and berm.

Looking North at building at landside toe.

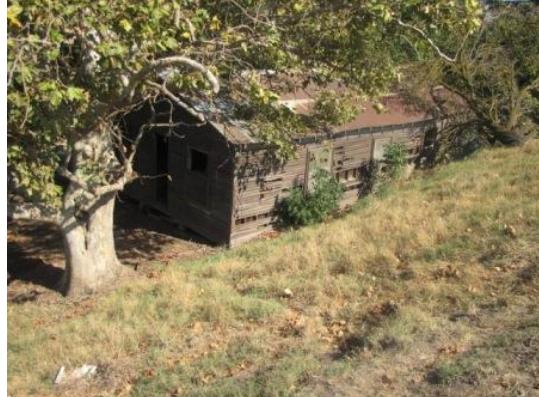
Photo 2 of 2 : FA_2015_RD0999_233_3_20150914_00005.jpg

Looking northeast at building at landside toe.

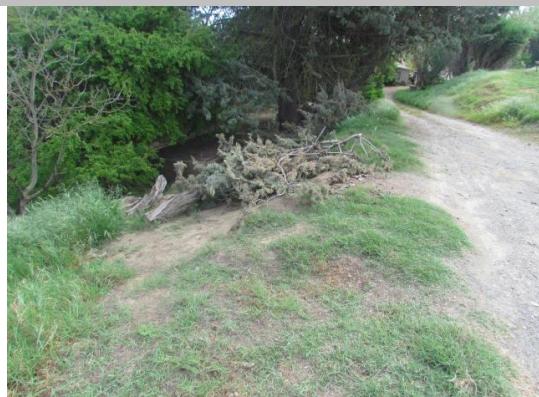
Photo 1 of 1 : FA_2015_RD0999_233_5_20150914_00006.jpg

LM Start	1.68	Rating **	M	Issue No.	5										
LM End	1.68	Issue Type +	En	Location *	LS										
Category	Earthen Levee		GPS Latitude/Longitude												
			Start	End											
Item	Encroachments		38.290248 °	38.290248 °											
			-121.615560 °	-121.615560 °											
DWR ID	DWR_RD0999_02_s_2012_5														
Action/Comments															
Tree or limb

Looking east at tree limbs on landward shoulder and slope. (Spring 2015)

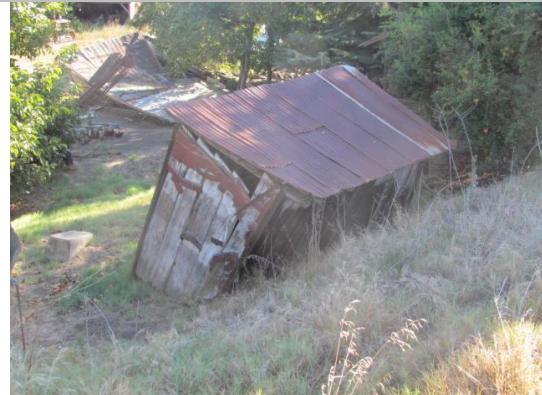
Photo 1 of 1 : FA_2015_RD0999_233_28_20150914_00031.jpg

LM Start	1.68	Rating **	U	Issue No.	28										
LM End	1.68	Issue Type +	En	Location *	LS										
Category	Earthen Levee			GPS Latitude/Longitude											
				Start	End										
Item	Encroachments			38.290260 °	38.290260 °										
				-121.615473 °	-121.615473 °										
DWR ID	DWR_RD0999_02_f_2013_28														
Action/Comments															
Building Inspector Comments: Abandoned pump house on landward toe.

Looking northeast at abandoned pump house on landward toe.

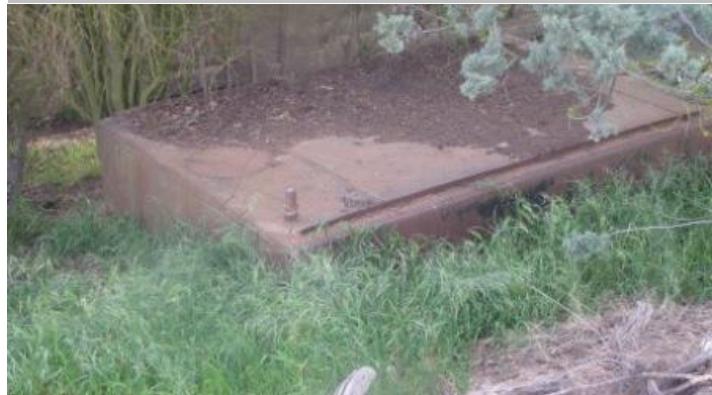
Photo 1 of 1 : FA_2015_RD0999_233_10_20150914_00012.jpg

LM Start	1.69	Rating **	U	Issue No.	10										
LM End	1.69	Issue Type +	En	Location *	LS										
Category	Earthen Levee			GPS Latitude/Longitude											
				Start	End										
Item	Encroachments			38.290195 °	38.290195 °										
				-121.615268 °	-121.615268 °										
DWR ID	DWR_RD0999_02_s_2012_10														
Action/Comments															
Tank

Looking north at a tank on the landside slope and toe.

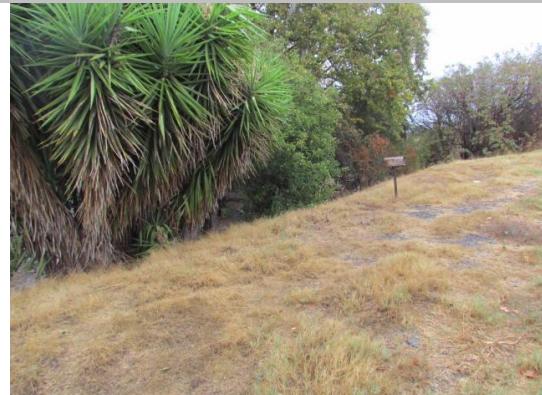
Photo 1 of 2 : FA_2015_RD0999_233_11_20151106_00048.jpg

Looking at dense trees on landward slope.

LM Start	1.70	Rating **	U	Issue No.	11										
LM End	1.70	Issue Type +	Ma	Location *	LS										
Category	Earthen Levee			GPS Latitude/Longitude											
				Start	End										
Item	Trim / Thin Trees			38.290171 °	38.290171 °										
				-121.615260 °	-121.615260 °										
DWR ID	DWR_RD0999_02_s_2012_11														
Action/Comments															
Trim trees to at least five feet above ground level.

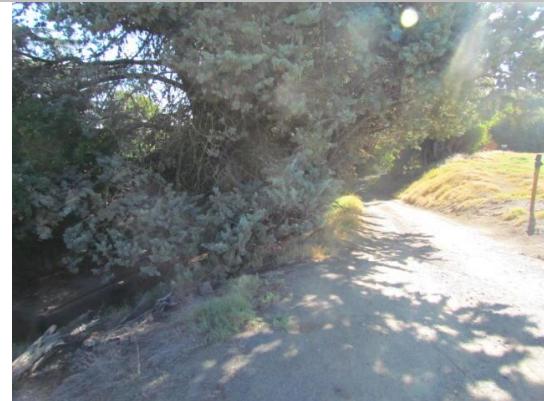
Photo 2 of 2 : FA_2015_RD0999_233_11_20150914_00013.jpg

Looking southwest at dense trees on landward slope.

LM Start	1.70	Rating **	U	Issue No.	11 (cont)												
LM End	1.70	Issue Type +	Ma	Location *	LS												
Category	Earthen Levee			GPS Latitude/Longitude													
				Start	End												
Item	Trim / Thin Trees			38.290171 °	38.290171 °												
				-121.615260 °	-121.615260 °												
DWR ID	DWR_RD0999_02_s_2012_11																
Action/Comments																	
Trim trees to at least five feet above ground level.

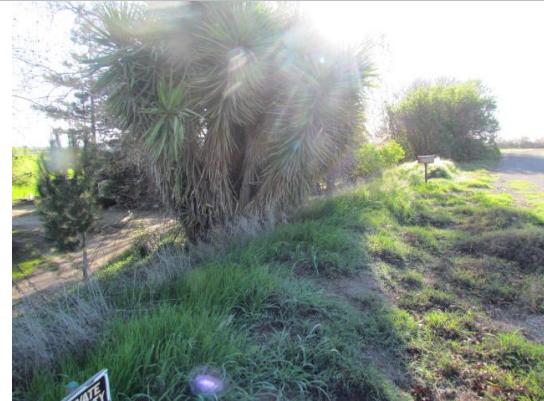
Photo 1 of 2 : FA_2015_RD0999_233_15_20150914_00016.jpg

LM Start	1.72	Rating **	U	Issue No.	15												
LM End	1.73	Issue Type +	En	Location *	LS												
Category	Earthen Levee			GPS Latitude/Longitude													
				Start	End												
Item	Vegetation			38.290026 °	38.289865 °												
				-121.614942 °	-121.614742 °												
DWR ID	DWR_RD0999_02_s_2012_15																
Action/Comments																	
Landscaping

Looking north at landscaping on landside slope.

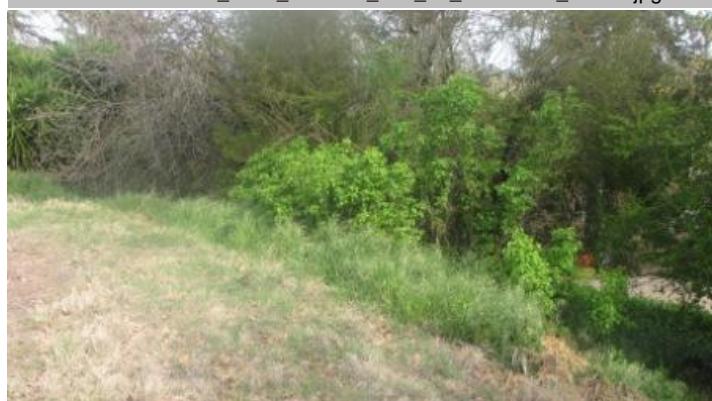
Photo 2 of 2 : FA_2015_RD0999_233_15_20150914_00017.jpg

Looking southwest at dense veg. on landside toe.

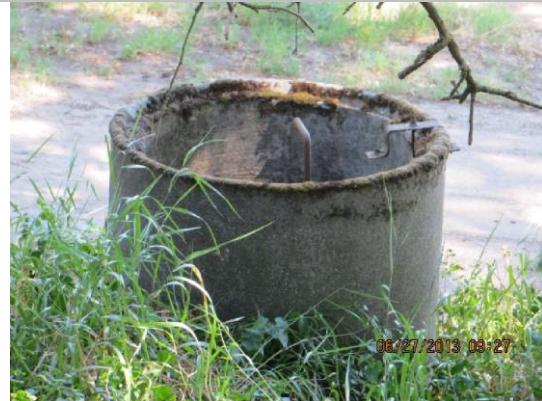
Photo 1 of 3 : UCIP_FA_2015_0984.jpg

Concrete standpipe on LS toe.

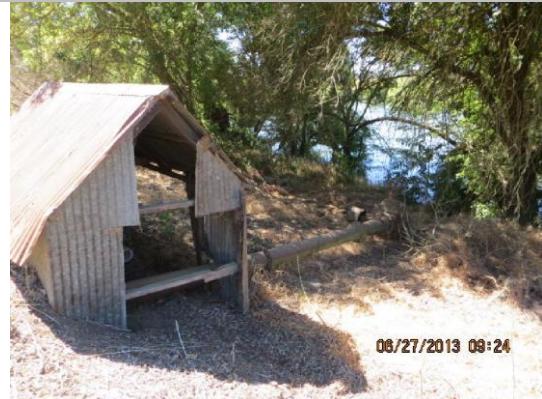
Photo 2 of 3 : UCIP_FA_2015_0985.jpg

Pipe, pumphouse, and gate valve on WS slope.

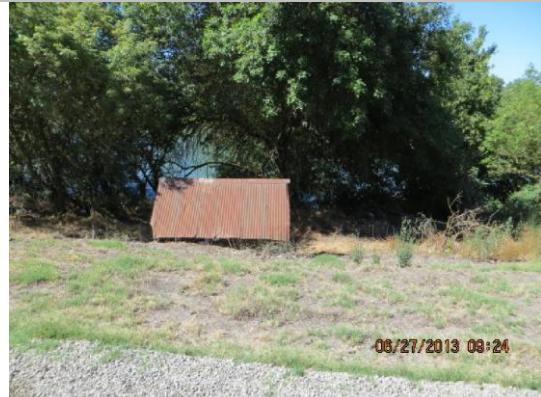
Photo 3 of 3 : UCIP_FA_2015_0986.jpg

Pumphouse on WS slope.

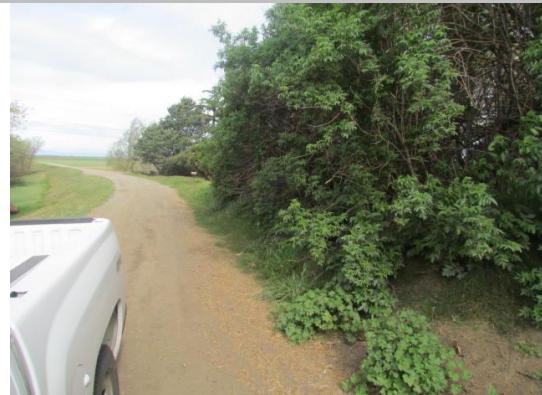
Photo 1 of 2 : FA_2015_RD0999_233_8_20150914_00010.jpg

LM Start	1.73	Rating **	M	Issue No.	8									
LM End	1.76	Issue Type +	Ma	Location *	LS									
Category	Earthen Levee			GPS Latitude/Longitude										
				Start	End									
Item	Vegetation			38.289895 °	38.289595 °									
				-121.614688 °	-121.614337 °									
DWR ID	DWR_RD0999_02_s_2012_8													
Action/Comments														
Remove the wild growth other than native grasses from the levee slopes.

Looking west at dense vegetation on landward shoulder and slope.
(Spring 2015)

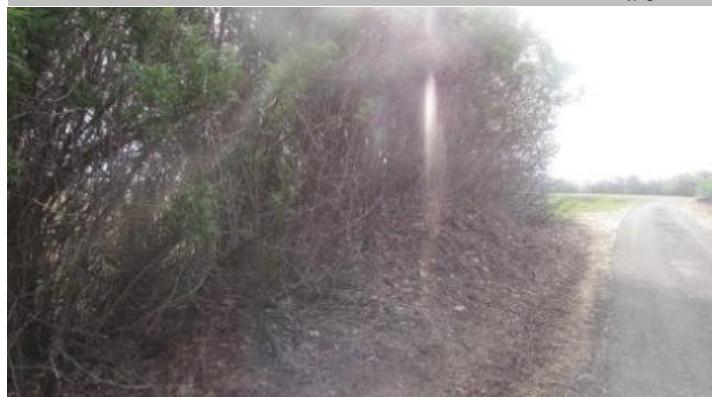
Photo 2 of 2 : FA_2015_RD0999_233_8_20150914_00011.jpg

Looking east at elderberry bush on landside shoulder and slope. (Fall 2014)

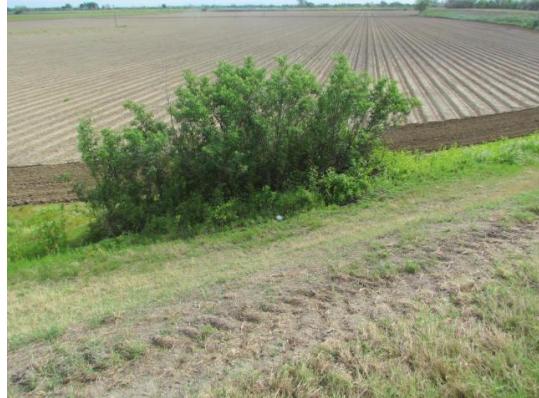
Photo 1 of 2 : FA_2015_RD0999_233_42_20150914_00035.jpg

LM Start	1.78	Rating **	M	Issue No.	42																				
LM End	1.78	Issue Type +	Ma	Location *	LS																				
Category	Earthen Levee			GPS Latitude/Longitude																					
				Start	End																				
Item	Vegetation			38.289399 °	38.289399 °																				
				-121.614130 °	-121.614130 °																				
DWR ID	DWR_RD0999_02_f_2014_42																								
Action/Comments																									
Elderberries are blocking visibility and flood fight capability. Inspector Comments: Elderberry and wildroses blocking landward toe.

Looking east at wild rose blocking landward toe. (Spring 2015)

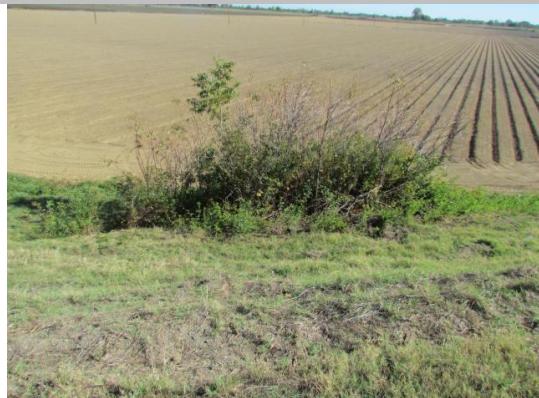
Photo 2 of 2 : FA_2015_RD0999_233_42_20150914_00036.jpg

Looking east at elderberry and wild roses blocking view of landward toe.

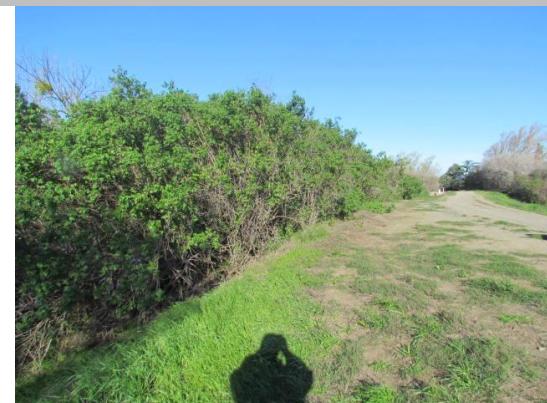
LM Start	1.78	Rating **	M	Issue No.	38	Photo 1 of 2 : FA_2015_RD0999_233_38_20150914_00032.jpg																
LM End	1.82	Issue Type +	Ma	Location *	WS																	
Category	Earthen Levee			GPS Latitude/Longitude																		
				Start	End																	
Item	Vegetation			38.289360 °	38.289006 °																	
DWR ID	DWR_RD0999_02_s_2014_38																					
Action/Comments																						
Elderberries are blocking visibility and flood fight capability.

Looking west at dense vegetation on waterside slope.

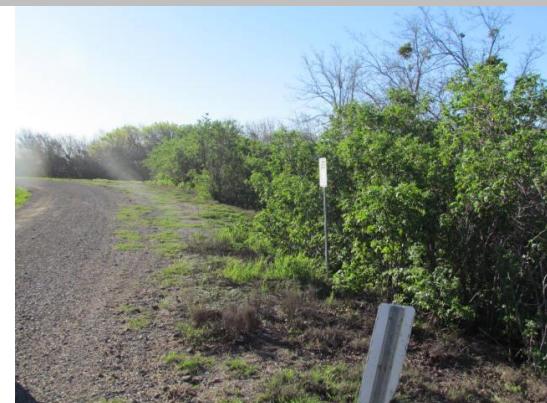
Looking east at dense vegetation on waterside slope.

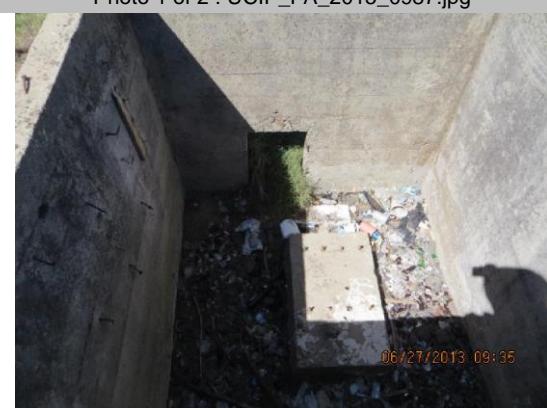
LM Start	1.78	Rating **	M	Issue No.	51	Photo 1 of 2 : UCIP_FA_2015_0987.jpg																
LM End	1.78	Issue Type +	En	Location *	WS																	
Category	Supplemental			GPS Latitude/Longitude																		
				Start	End																	
Item	DWR UCIP Field Study			38.289357 °	38.289357 °																	
DWR ID																						
Action/Comments																						
Inspector Comments: FS_ID:41069 DS_ID:22775 EP_NO: N/A FS_HLM: 1.772 Repair Type: Non-Urgent Crossing Status: Indicator Found

Pump mount inside foundation at WS slope.

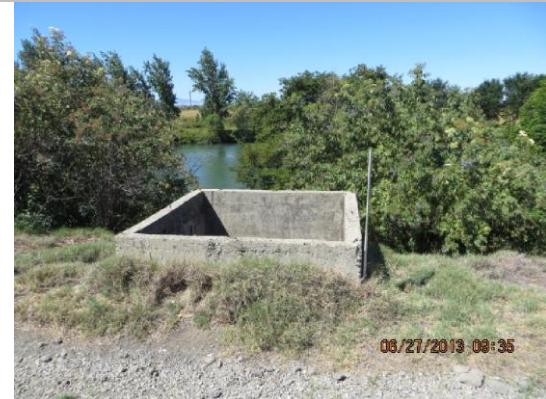
Photo 2 of 2 : UCIP_FA_2015_0988.jpg

LM Start	1.78	Rating **	M	Issue No.	51 (cont)									
LM End	1.78	Issue Type +	En	Location *	WS									
Category	Supplemental			GPS Latitude/Longitude										
				Start	End									
Item	DWR UCIP Field Study			38.289357 °	38.289357 °									
				-121.614089 °	-121.614089 °									
DWR ID														
Action/Comments														
Inspector Comments: FS_ID:41069 DS_ID:22775 EP_NO: N/A FS_HLM: 1.772 Repair Type: Non-Urgent Crossing Status: Indicator Found UCIP Comments: Appears abandoned. FIELD_STRUCT_DESC: 8-inch pipe through levee 4.0 feet below crown. Used during irrigation season with portable pump. 7'X7' concrete pumphouse sump on WS shoulder with pump mount. Originally included in the 1966 O&M manual. FS Date: 06/27/2013

7'X7' concrete pumphouse sump on WS shoulder.

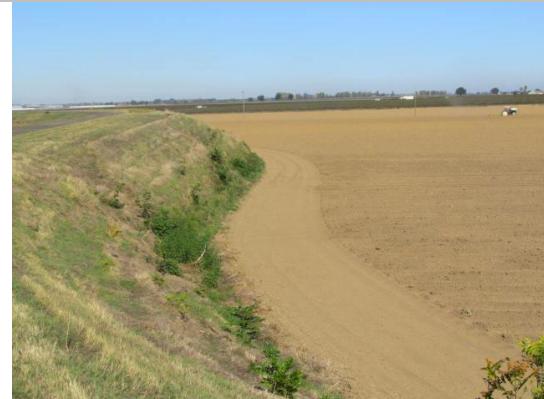
Photo 1 of 2 : FA_2015_RD0999_233_22_20150914_00024.jpg

LM Start	1.81	Rating **	A/W	Issue No.	22										
LM End	2.32	Issue Type +	En	Location *	LS										
Category	Earthen Levee		GPS Latitude/Longitude												
			Start	End											
Item	Encroachments		38.289002 °	38.286742 °											
			-121.613675 °	-121.605903 °											
DWR ID	DWR_RD0999_02_s_2012_22														
Action/Comments															
Crops Inspector Comments: Crops encroached within ten feet of the landside toe.

Looking west proper toe road at landward toe.(Fall 2014)

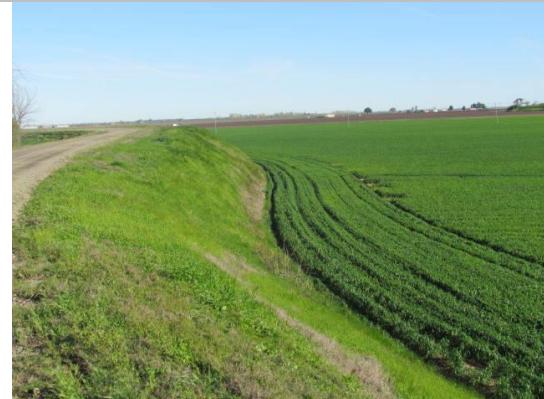
Photo 2 of 2 : FA_2015_RD0999_233_22_20150914_00025.jpg

Looking west at crops encroaching on landside toe.

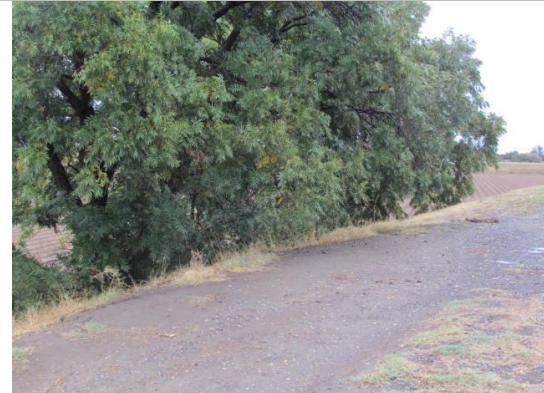
Photo 1 of 1 : FA_2015_RD0999_233_29_20151106_00049.jpg

LM Start	2.06	Rating **	U	Issue No.	29	
LM End	2.07	Issue Type +	Ma	Location *	LS	
Category	Earthen Levee			GPS Latitude/Longitude		
				Start	End	
Item	Trim / Thin Trees			38.288870 °	38.288844 °	
				-121.609259 °	-121.609008 °	
DWR ID	DWR_RD0999_02_f_2013_29					
Action/Comments						
Trim trees to at least five feet above ground level.

Looking at untrimmed trees on landward slope fall 2015.

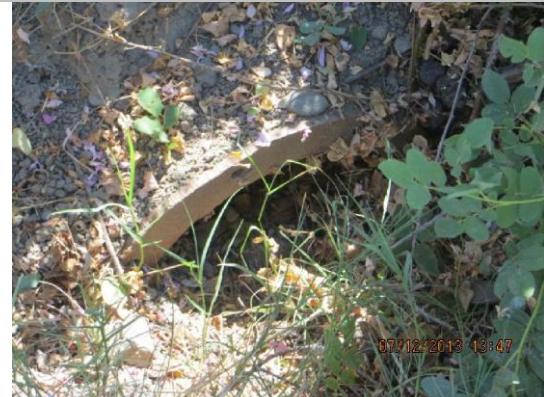
Photo 1 of 3 : UCIP_FA_2015_1446.jpg

LM Start	2.27	Rating **	M	Issue No.	52																	
LM End	2.27	Issue Type +	En	Location *	LS																	
Category				GPS Latitude/Longitude																		
				Start	End																	
Item				38.286666 °	38.286666 °																	
				-121.606803 °	-121.606803 °																	
DWR ID																						
Action/Comments																						
Inspector Comments: FS_ID:15703 DS_ID:22770 EP_NO: 3855 FS_HLM: 2.265 Repair Type: Non-Urgent Crossing Status: Found UCIP Comments: Pipe not capped on LS and not found on WS. FIELD_STRUCT_DESC: 10-inch steel irrigation pipe through the levee 4.0 feet below the crown. Capped during winter months. 6-inch pipe sleeved through 10-inch during irrigation season (Permit No. 3855, 1962). Included in the 1966 O&M manual. FS Date: 06/27/2013

Pipe partially filled with soil and open on LS.

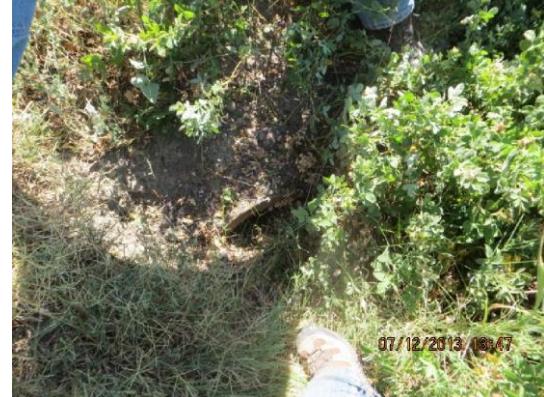
Photo 2 of 3 : UCIP_FA_2015_1447.jpg

Pipe visible just off shoulder on LS slope in the rose bushes.

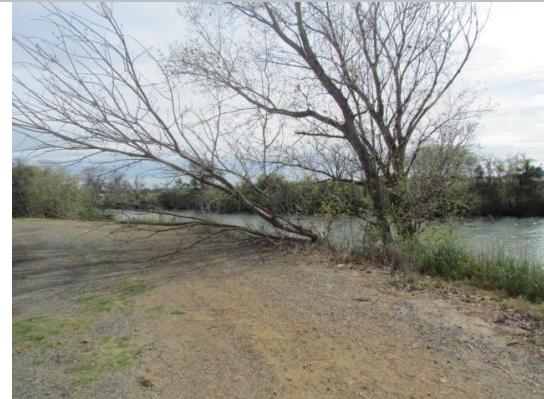
Photo 1 of 1 : FA_2015_RD0999_234_39_20150914_00029.jpg

LM Start	0.01	Rating **	A/W	Issue No.	39										
LM End	0.01	Issue Type +	En	Location *	WS										
Category	Earthen Levee			GPS Latitude/Longitude											
				Start	End										
Item	Encroachments			38.286727 °	38.286727 °										
				-121.606004 °	-121.606004 °										
DWR ID	DWR_RD0999_03_s_2015_39														
Action/Comments															
Tree or limb Inspector Comments: Downed tree on waterward shoulder.

Looking northeast at fallen tree on waterward shoulder. (Spring 2015)

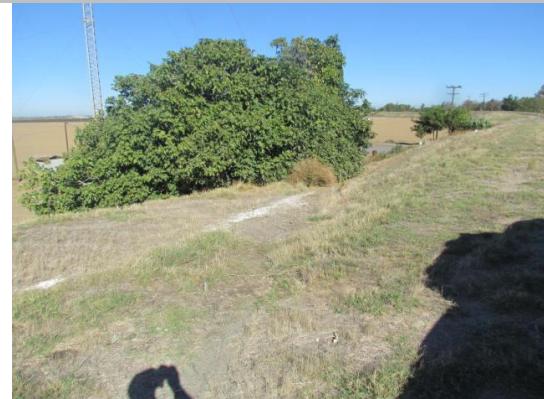
Photo 1 of 4 : FA_2015_RD0999_234_4_20150914_00003.jpg

LM Start	0.04	Rating **	A/W	Issue No.	4										
LM End	0.04	Issue Type +	Ma	Location *	LS										
Category	Earthen Levee			GPS Latitude/Longitude											
				Start	End										
Item	Trim / Thin Trees			38.287025 °	38.287025 °										
				-121.605690 °	-121.605690 °										
DWR ID	DWR_RD0999_03_s_2012_4														
Action/Comments															
Trim trees to at least five feet above ground level. Inspector Comments: Dense fig trees on landward slope and toe.

Looking northwest at dense fig tree on landward toe. 2014

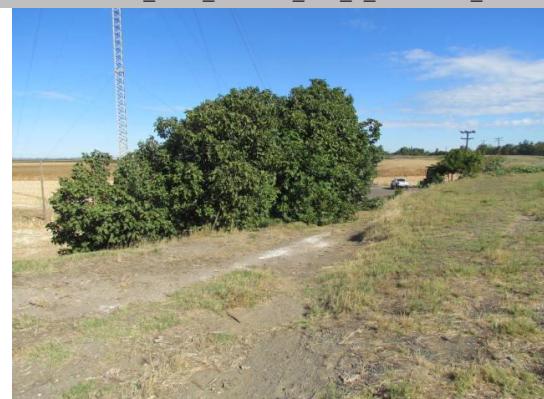
Photo 2 of 4 : FA_2015_RD0999_234_4_20150914_00004.jpg

Looking northwest at dense fig tree on landward slope and toe. 2013

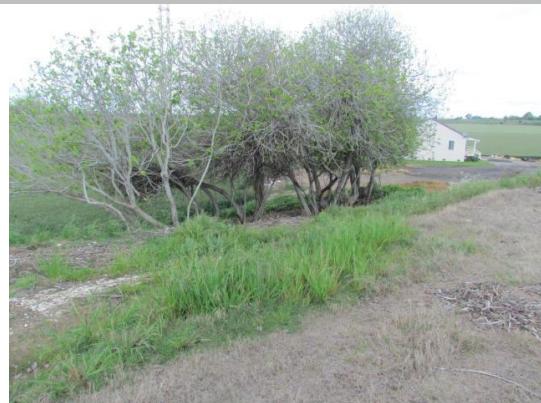
Photo 3 of 4 : FA_2015_RD0999_234_4_20150914_00005.jpg

LM Start	0.04	Rating **	A/W	Issue No.	4 (cont)	
LM End	0.04	Issue Type +	Ma	Location *	LS	
Category	Earthen Levee			GPS Latitude/Longitude		
Item	Trim / Thin Trees			Start	End	
DWR ID	DWR_RD0999_03_s_2012_4			38.287025 °	38.287025 °	
Action/Comments						
Trim trees to at least five feet above ground level. Inspector Comments: Dense fig trees on landward slope and toe.

Looking southwest at trimmed trees on landside toe. (Spring 2012)

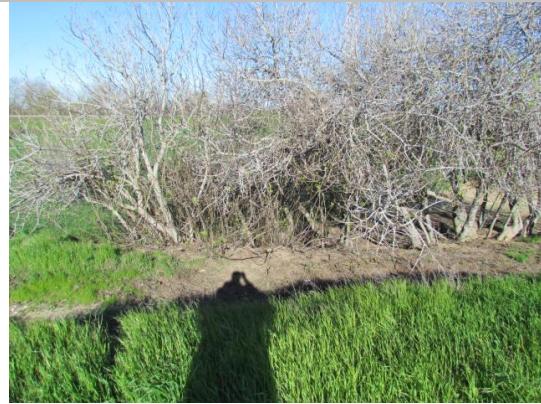
Photo 4 of 4 : FA_2015_RD0999_234_4_20150914_00006.jpg

Looking west at dense fig trees at landside toe.

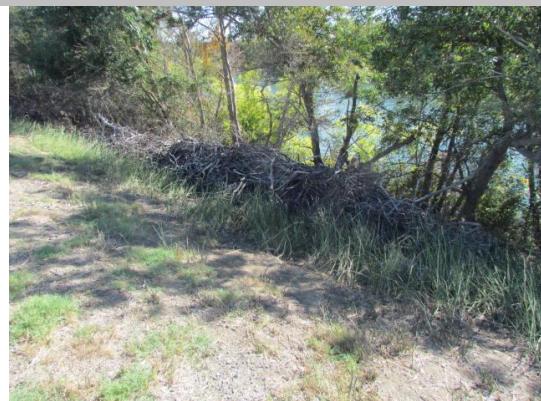
Photo 1 of 1 : FA_2015_RD0999_234_36_20150914_00028.jpg

LM Start	0.04	Rating **	M	Issue No.	36	
LM End	0.04	Issue Type +	Ma	Location *	WS	
Category	Earthen Levee			GPS Latitude/Longitude		
Item	Encroachments			Start	End	
DWR ID	DWR_RD0999_03_f_2013_36			38.287025 °	38.287025 °	
Action/Comments						
Prunings Inspector Comments: Prunings on waterward slope outside the twenty feet zone should be burned or removed from levee slope.

Looking east at prunings on waterward slope.
